Technical Summary Memorandum
Dam Feasibility and Impact Analysis
Macallen Dam, Newmarket, NH

Town of Newmarket, New Hampshire

GOMEZ AND SULLIVAN
Engineers, P.C.

January 2014

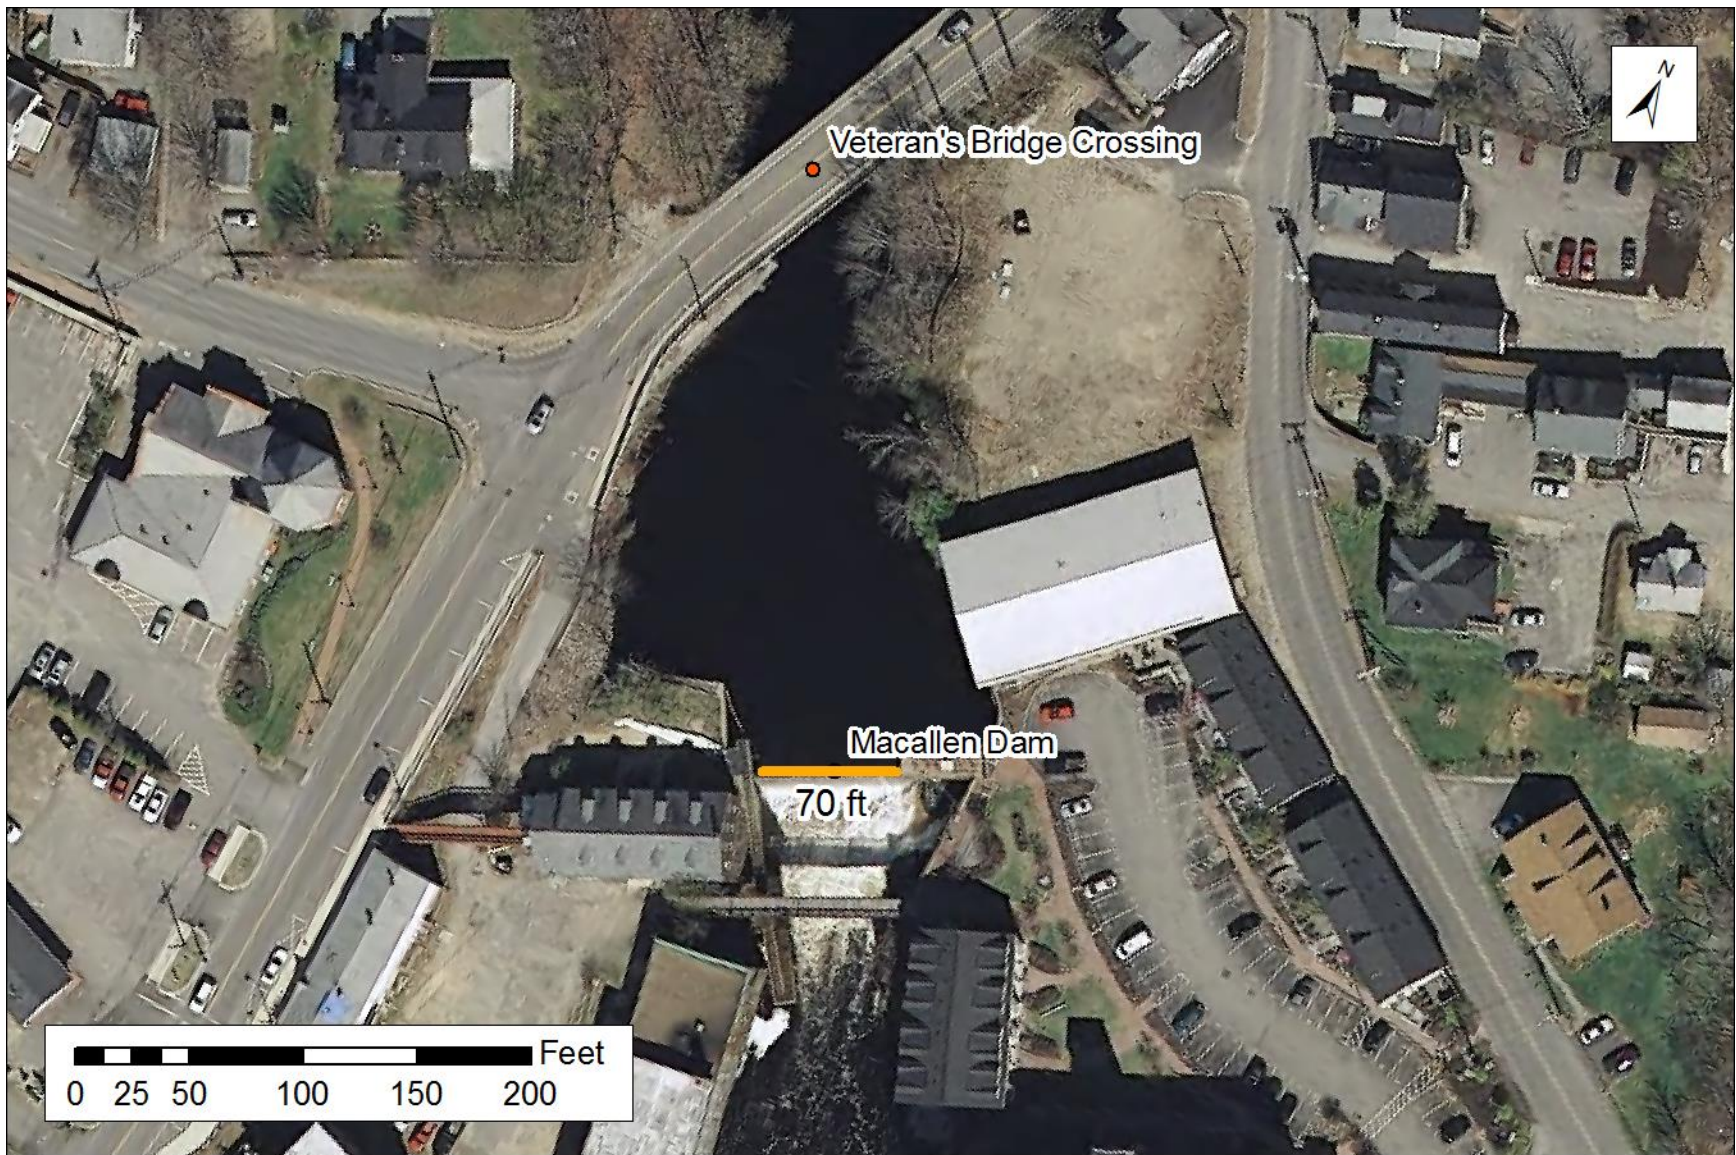
Figure 2: Aerial close-up of Macallen Dam.

The Macallen Dam is located on the Lamprey River in downtown Newmarket. Figure 1 is an aerial map of the impoundment. Figure 2 is a close up aerial view of the dam. Based on existing mapping and survey conducted under this contract, an existing conditions plan in the dam area was developed as shown in Figure 3. The dam is readily visible from Veteran's Bridge located immediately upstream of the dam, from the footbridge spanning the Lamprey River below the dam, and from various locations on each side of the river. There is considerable infrastructure development around the dam including buildings and parking lots as shown in Figure 2 and Figure 3. The dam creates an impoundment extending upstream approximately 2.5 miles up the Lamprey River and approximately 0.75 miles up the Piscassic River – a major tributary to the Lamprey River. The impoundment extends into Durham, NH and creates several backwater/bay

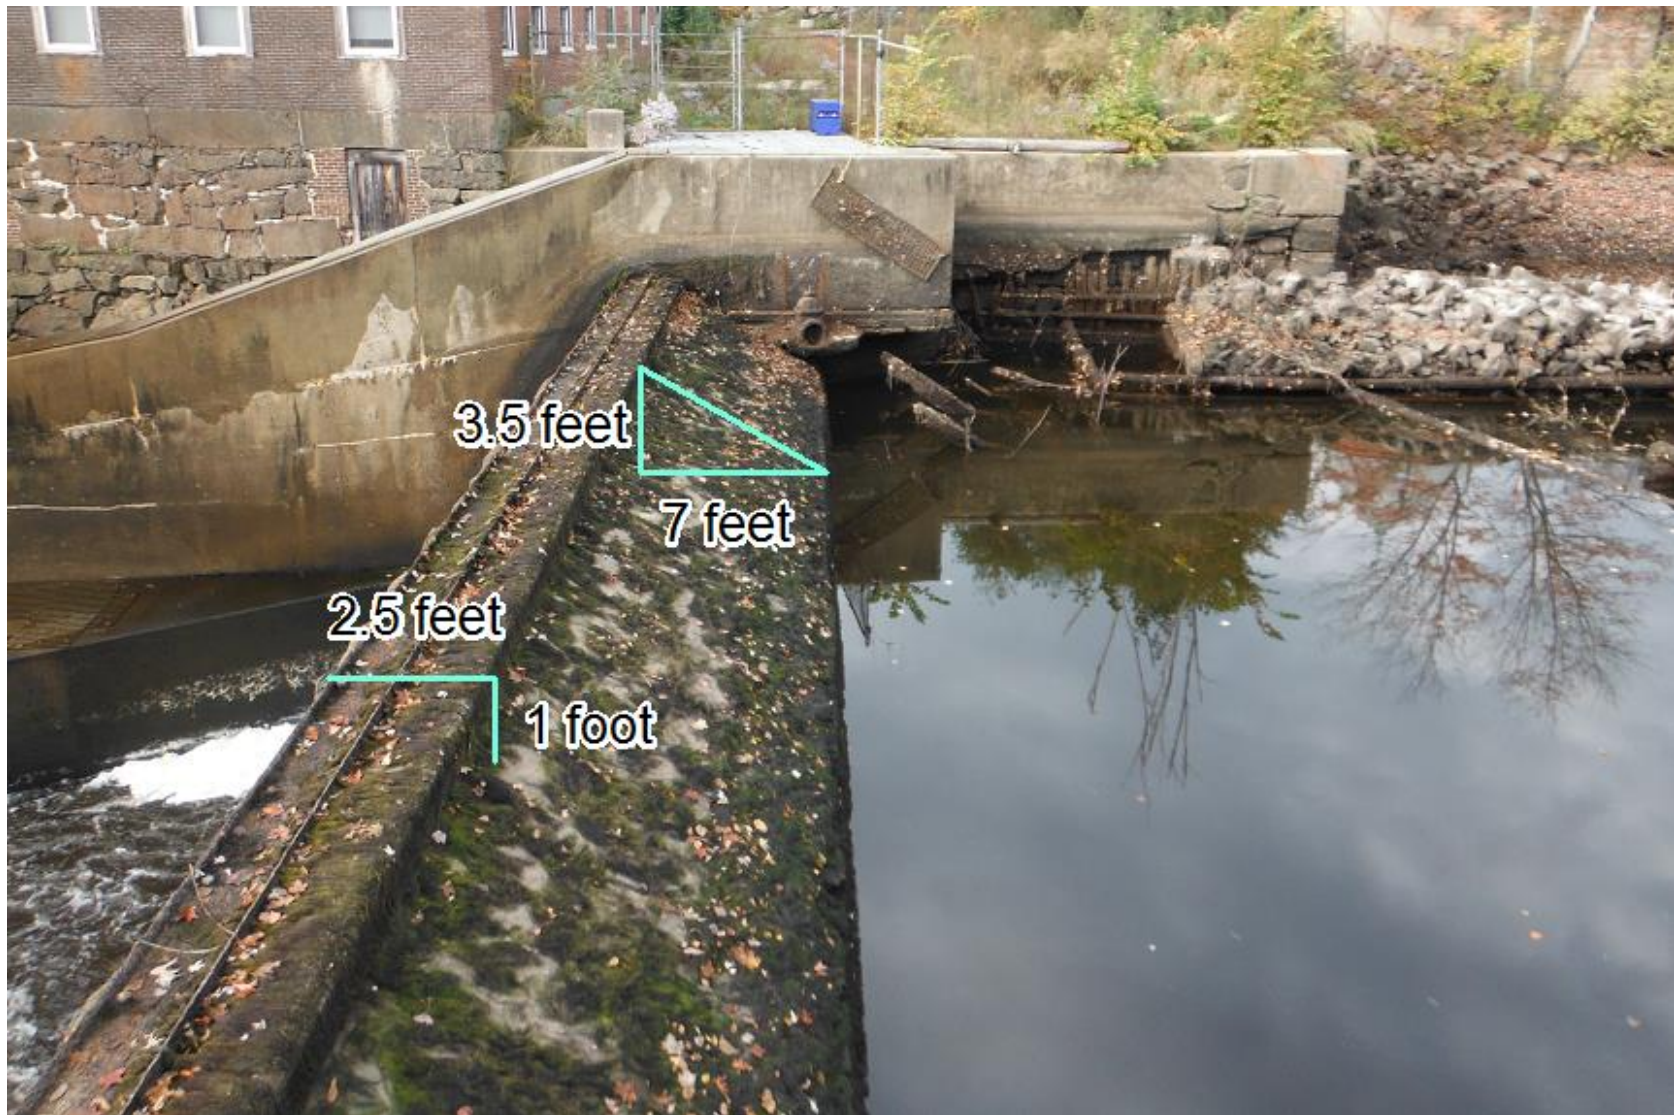
Figure 5: Photo of the dam's right abutment and spillway sections, including geometry of the sloped upstream face of the dam. Photo taken during the October 2013 drawdown. Note the metal lip running along the center of the spillway crest.

The dam consists of three main sections (Figure 4, Figure 5, and Figure 6): the right² abutment, the spillway section, and the left abutment/gate section. The right abutment is a stone-block and concrete wall, which is structurally attached to the fish ladder. The right abutment has a crest elevation of 28.47 feet³. Immediately below the right abutment is a brick building currently housing a commercial business. The building appears to be structurally tied to the fish ladder. The spillway is constructed of stone-block, with a crest elevation of 22.35 feet⁴. There is a small metal lip along the center of the spillway (crest elevation 22.42 feet) that further controls water levels. The lip appears to be a relic from when the dam had flashboards⁵ installed. The left abutment/gate section is a stone-block and concrete section with three 7 foot by 7 foot manually-operated crest gates. The gates have a crest elevation of 16.15 feet and a

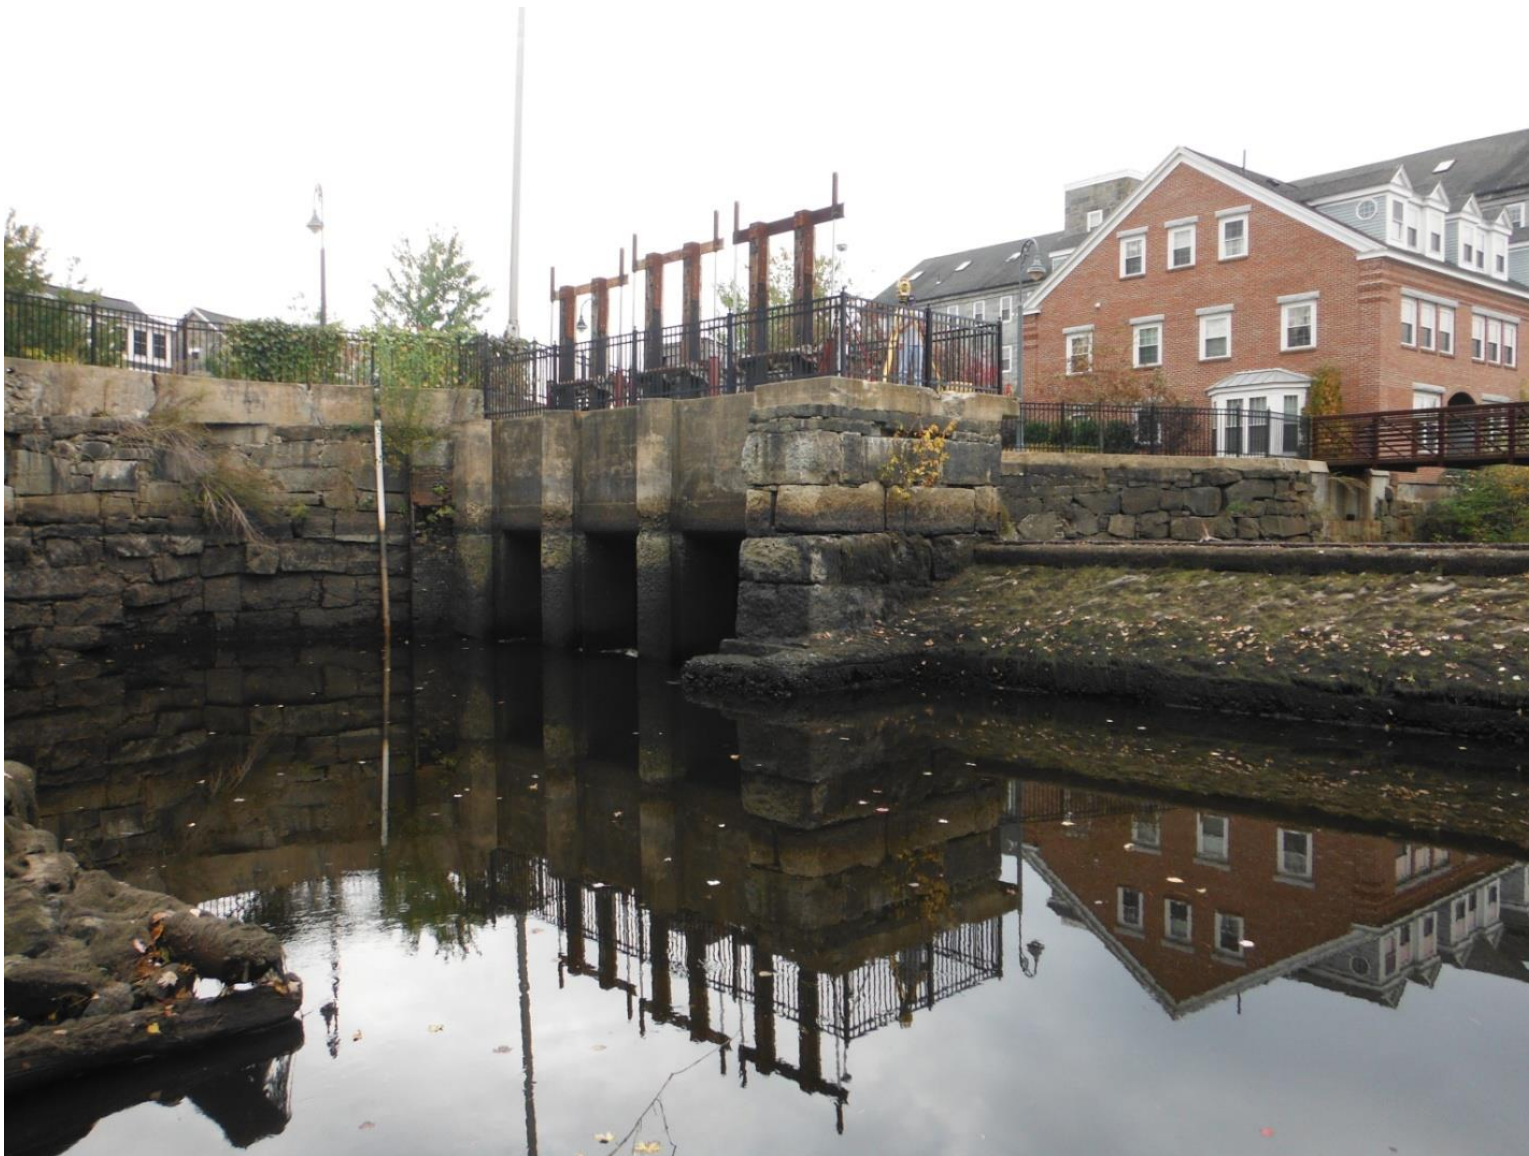
Figure 6:Left abutment and crest gates. Photo taken during the October 2013 drawdown.

top elevation of 23.15 feet. While the gates are 7 feet tall, the NHDES September 17, 2010 inspection report states that the gates cannot fully open and listed 5.5 feet above the crest as the maximum opening height (elevation 21.65 feet). With a gate crest elevation of 16.15 feet and a spillway crest elevation of 22.42 feet (at the metal lip), the water level behind the dam can be lowered up to 6.3 feet. The left abutment, located above the gates, has a crest elevation of 30.20 feet.

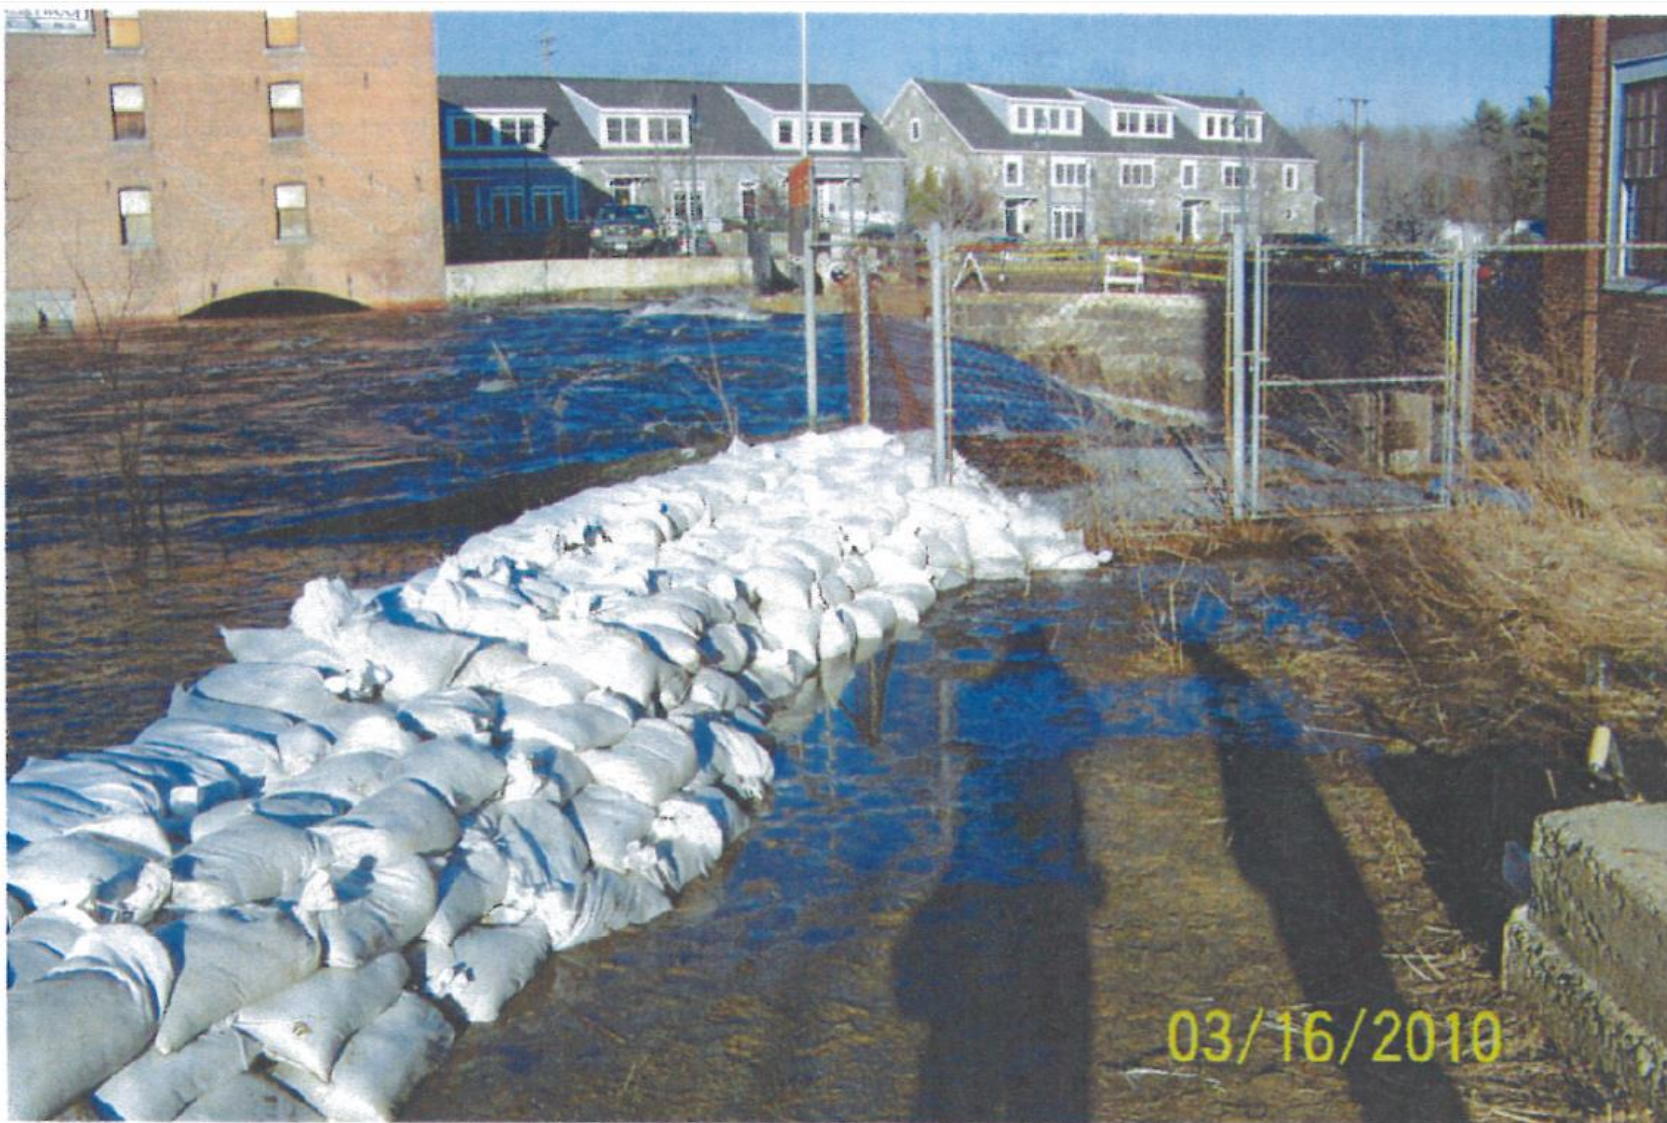
Figure 7: Macallen Dam during the March 16, 2010 flood event. Flow is approximately 6,710 cfs. Photo is taken from the right abutment, looking toward the spillway and left abutment. Photo source: NHDES Dam Bureau.

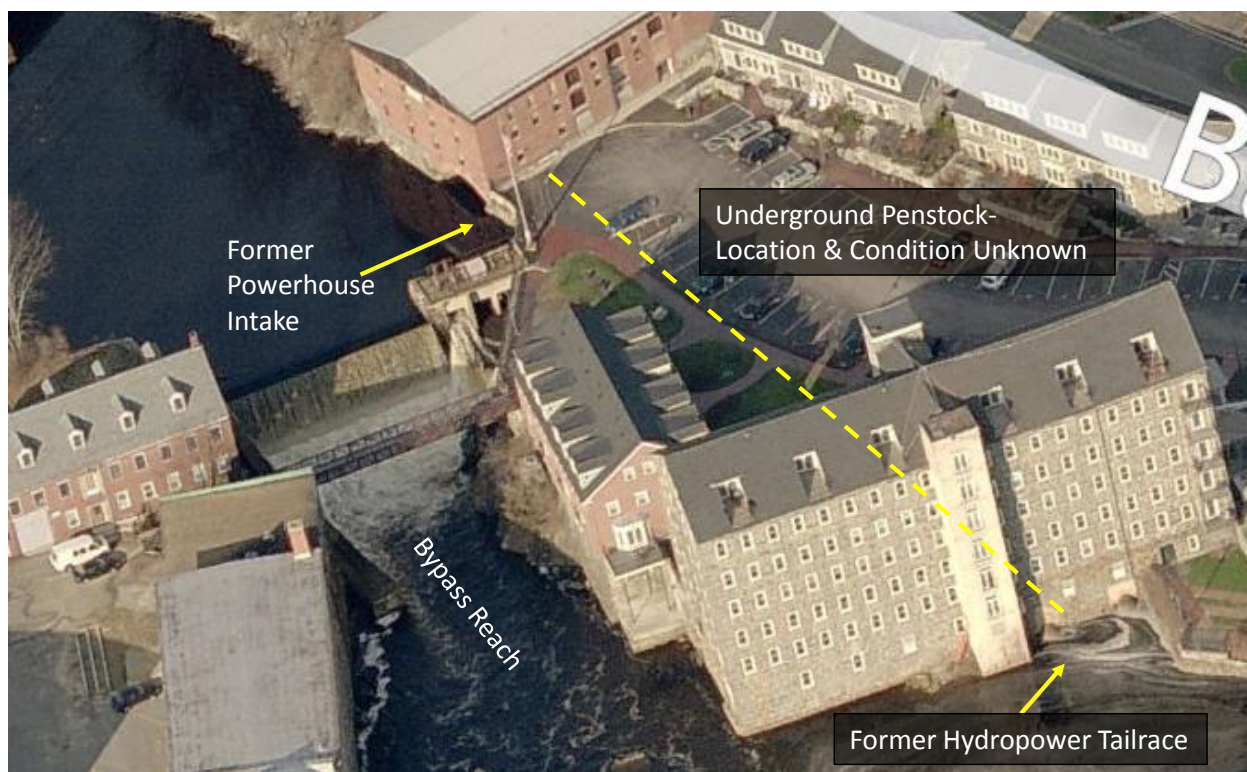
Figure 17: Aerial view of Macallen Dam's former hydroelectric works.

There has been considerable discussion about resurrecting hydroelectric power at the Macallen Dam, which previously generated hydroelectric power until the 1950s. It is our understanding that at one time, there was a 500 kilowatt (KW) turbine on the left side of the river and a 50 KW turbine on the right side. It appears that the intake for the 500 KW turbine was located at the arch at the building located adjacent to the dam, and then conveyed flow via an underground penstock to a turbine located in the basement of a building (Figure 17).

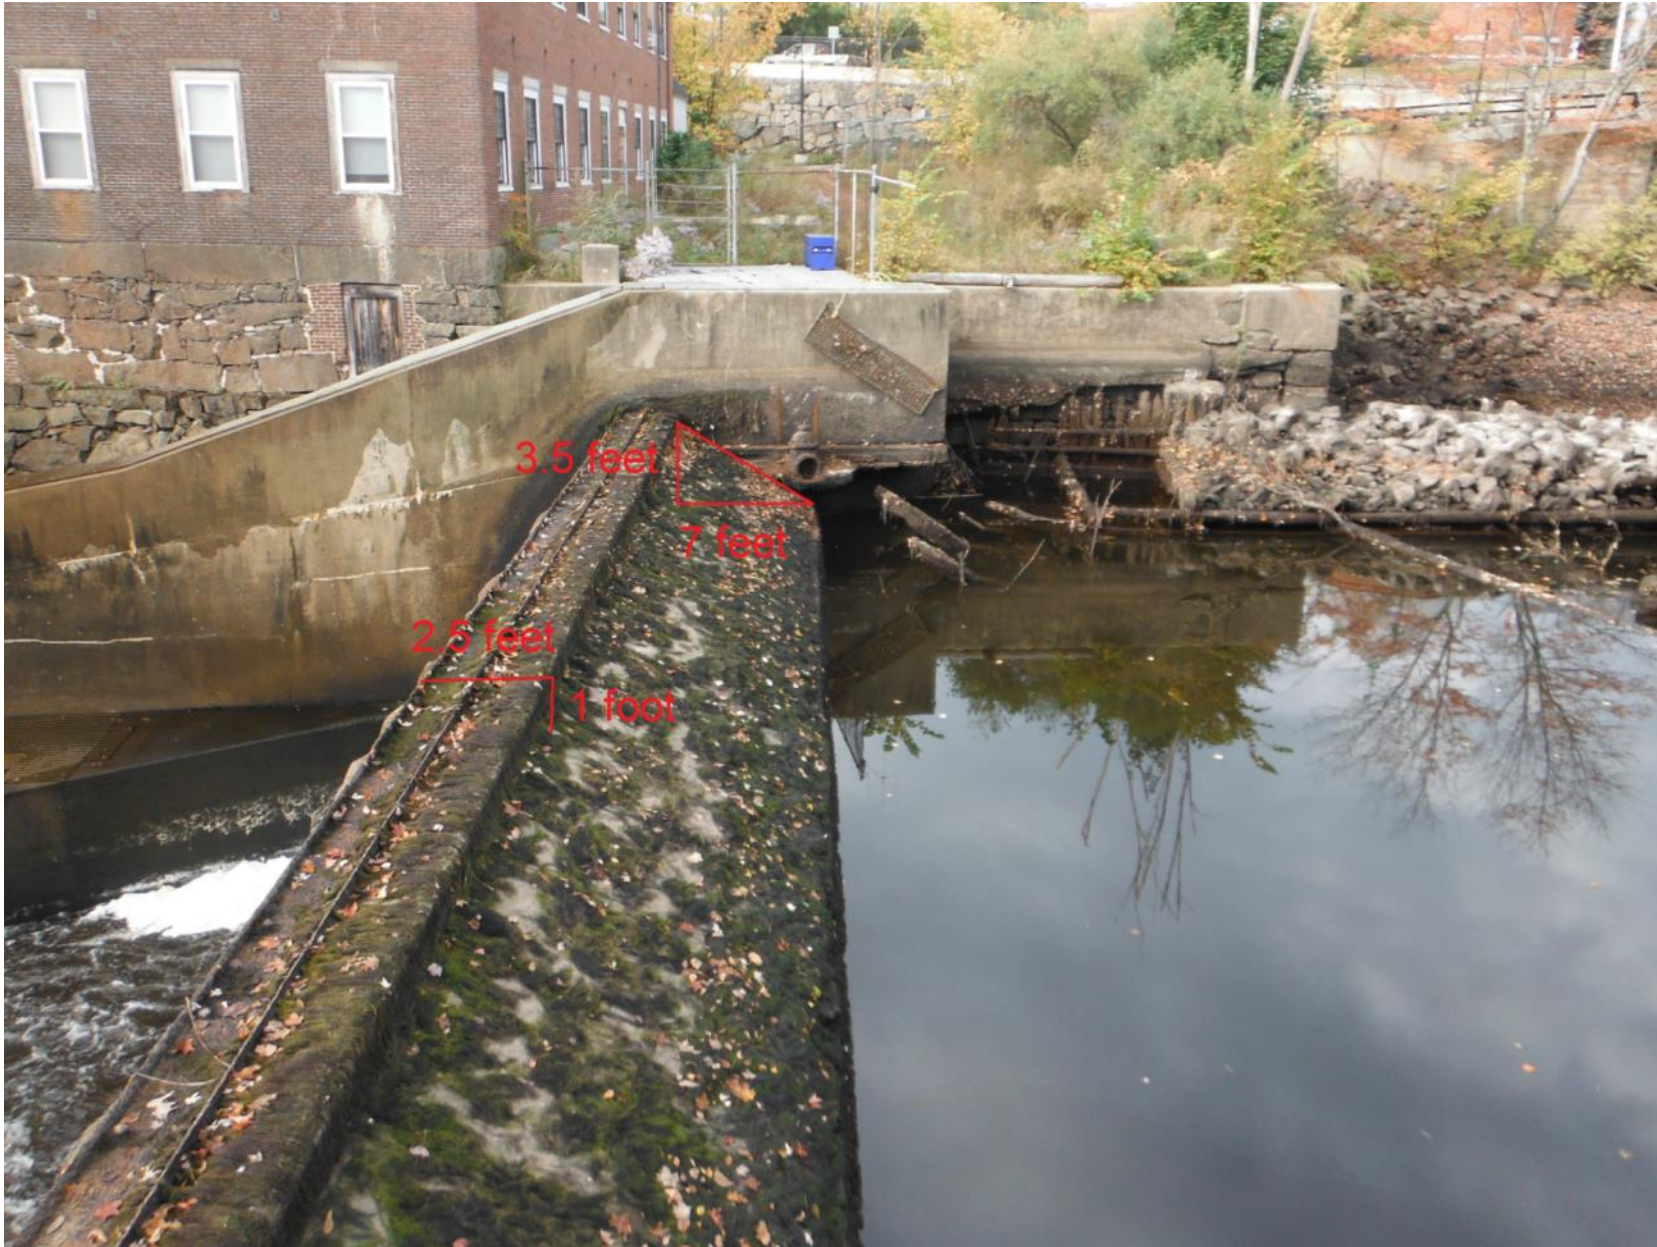
Figure A-1: Side-view of Macallen Dam.

The dam’s geometry is different than a typical broad-crested weir. In particular, the dam features a sloping upstream face (2:1 slope, 3.5’ rise, 7’ long), with a 1’ tall by 2.5’ wide “step” on the top of the dam (Figure A-1). There is also a small metal lip in the center of the spillway that is approximately 2” tall. Given the dam’s shape, it is possible that the dam spillway could act more like a trapezoidal weir under certain flow conditions. To remain conservative (i.e., not overestimate the spillway flow capacity), however, we suggest modeling the dam as a broad-crested weir rather than as a trapezoidal weir.
